DAIRY BARN

The Dairy Barn was built in 1897 with \$19,000 in state funds obtained by Dean Henry. The silo was an early experiment in round silo design. The building has lost some detail and been added to over the years, but is still sound, and is now in limited use for animal experimentation.

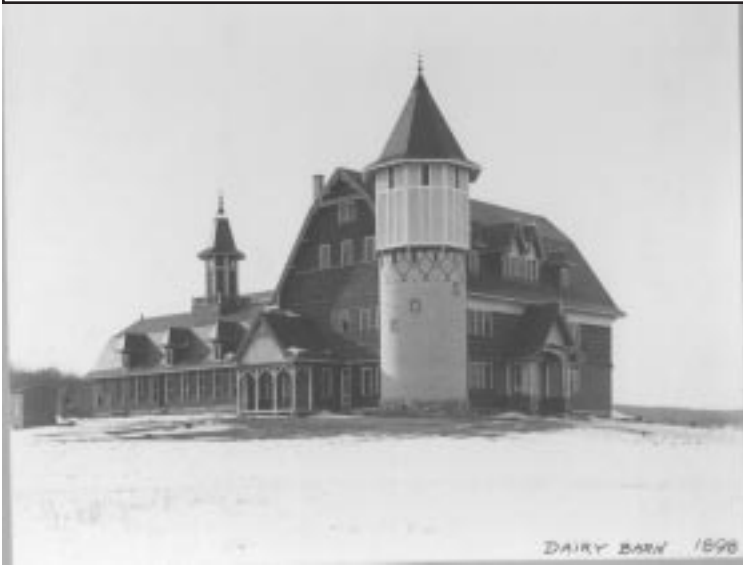
Fig. 1. The Dairy Barn shortly after completion in 1898. Much detail, including cupolas, silo windows, the north side window pattern, and assorted trim, has been lost over the decades. [series 9/3 Dairy Barn, jf-24]

Jennings designed the building's exterior to emulate the style of barns in Normandy. The main building was 50 X 96 feet, three stories high above a high basement. Two 40 by 70 foot one and a half story cattle stable barns projected toward the south from the east and west ends of the main barn. Between the two stables and connected to the main barn was a two story stock judging barn. The fact that the barn was lighted with electricity in that long ago day caused amazed comment.¹ Other features of the building were an office and apartment for the director, and a long steel ramp on the west side, navigable by teams of horses from the ground to the hay loft on the third floor. (See Fig. 2.).² These features have been mostly lost in the last 100 years. Much other detail has been lost. The original slate roof has been replaced with asphalt shingles.

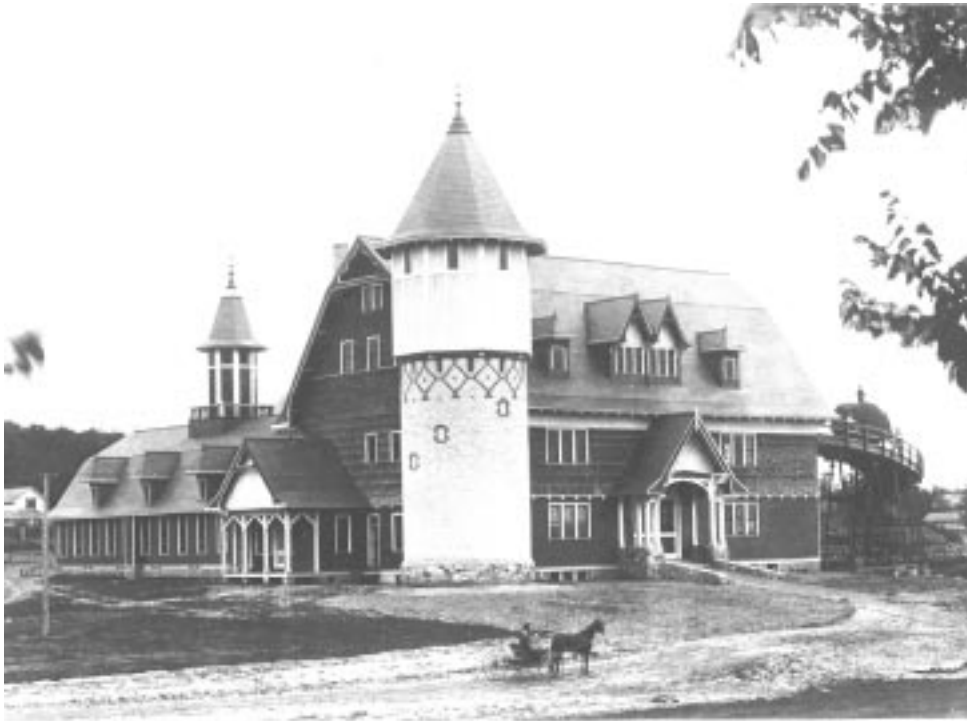
Fig. 2. The Dairy Barn about 1905 showing spiral ramp in rear (west) of barn. A team of horses pulling a loaded wagon could enter the third level hay loft directly by climbing this ramp. [x25-336]
